# Preliminary Findings from VDOT Demo on Dowel Alignment Using Magnetic Imaging Tool Scan-2

Mohamed Elfino, P.E., Ph.D.  
Assistant State Materials Engineer  
Shabbir Hossain, P.E., Ph.D.  
Research Scientist, VTRC

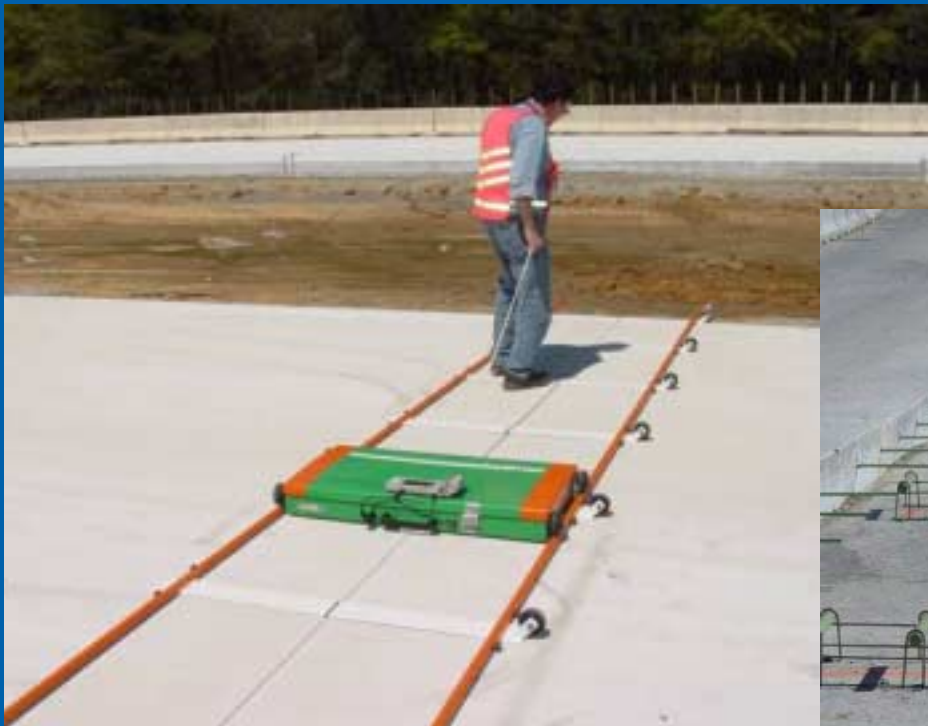
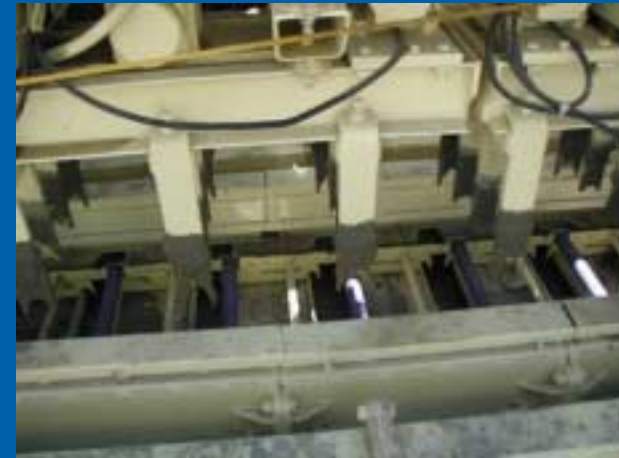
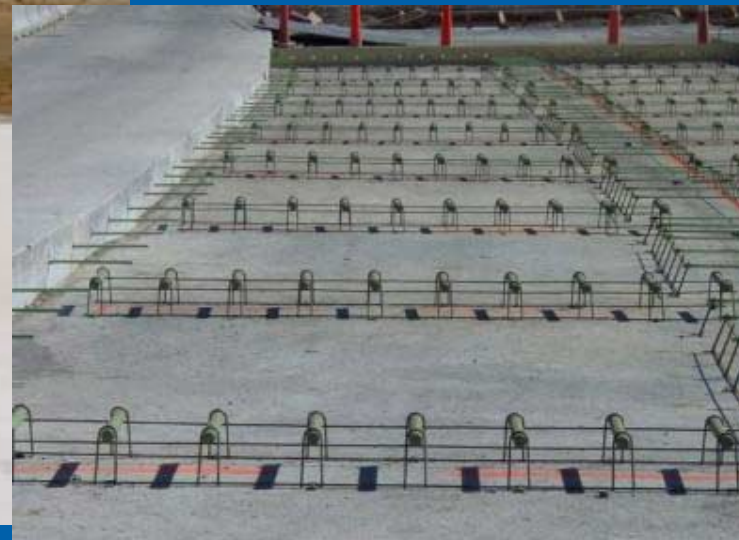
Device designed specifically for the measurement of dowel bar position and alignment

Designed specifically for measuring dowel bar position and alignment using Magnetic tomography technology.

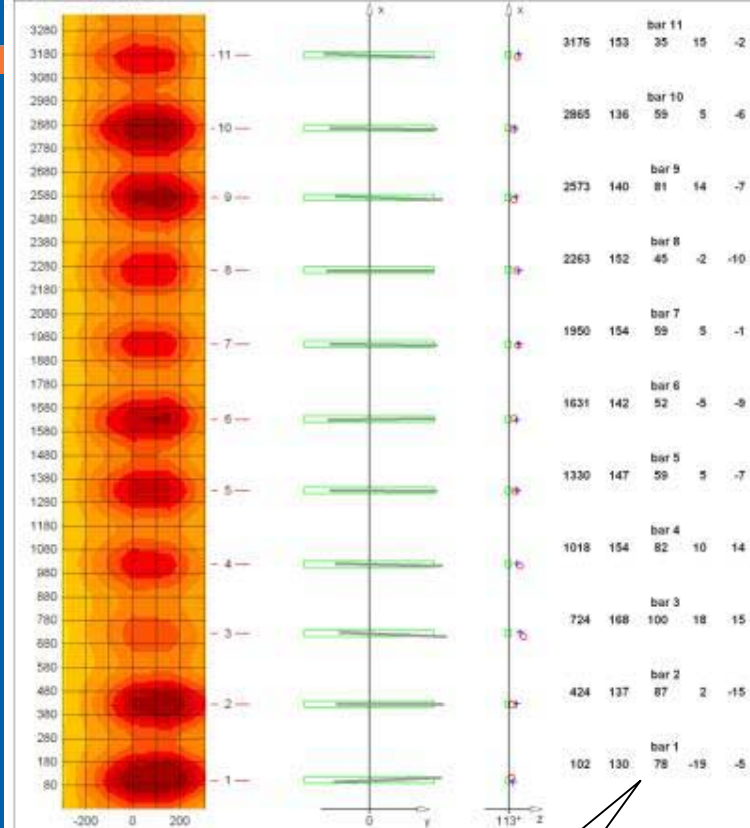
File name: D2610120.HDF

Highway: US 295  
Direction:  
Lane: Lane 1  
Station No.: 0 + 55  
Joint: 12  
Bar type: 453 x 35.0  
Time: 12/28/2005 10:12:00 AM  
Slab thickness: 225 mm  
Basket: No basket

xs - X-Position  
zs - Depth  
dy - Side shift  
sh - Horiz. Misalignment  
sv - Vert. Misalignment  
\* - Norm depth  
+ - Left end of bar  
o - Right end of bar  
Unit: Millimeter

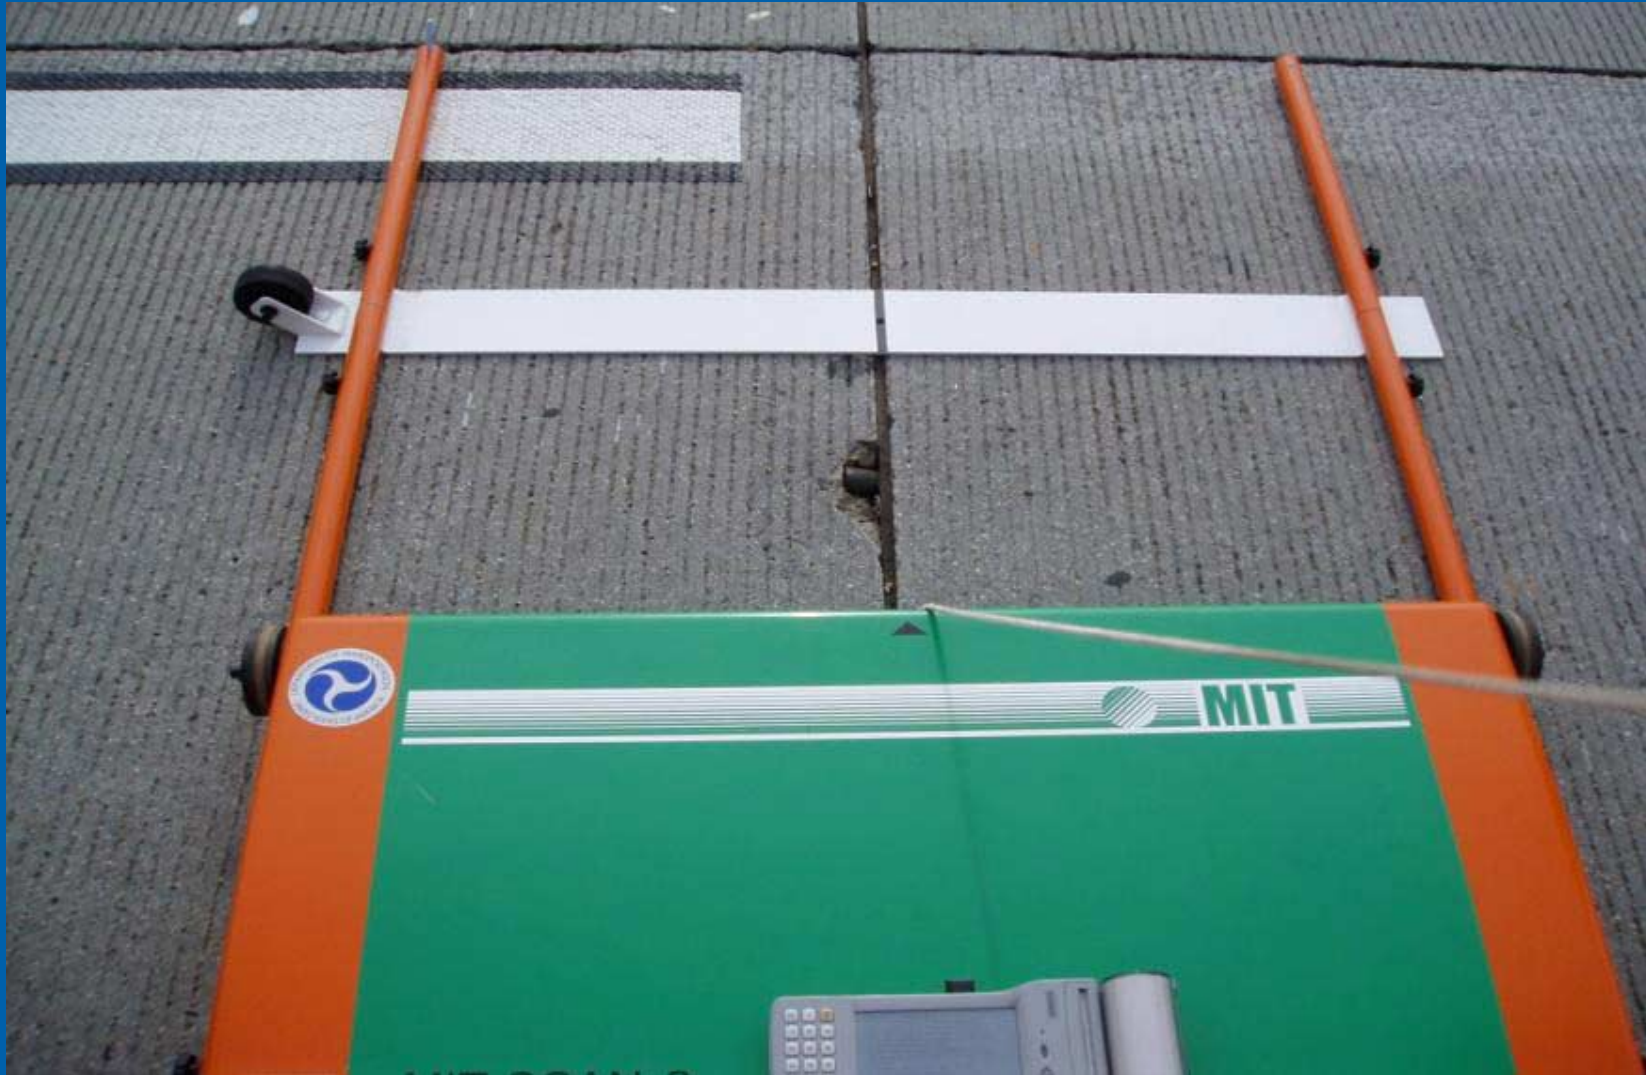
# Typical Results: I-66

Joint 54 (Travel Lane and shoulder)

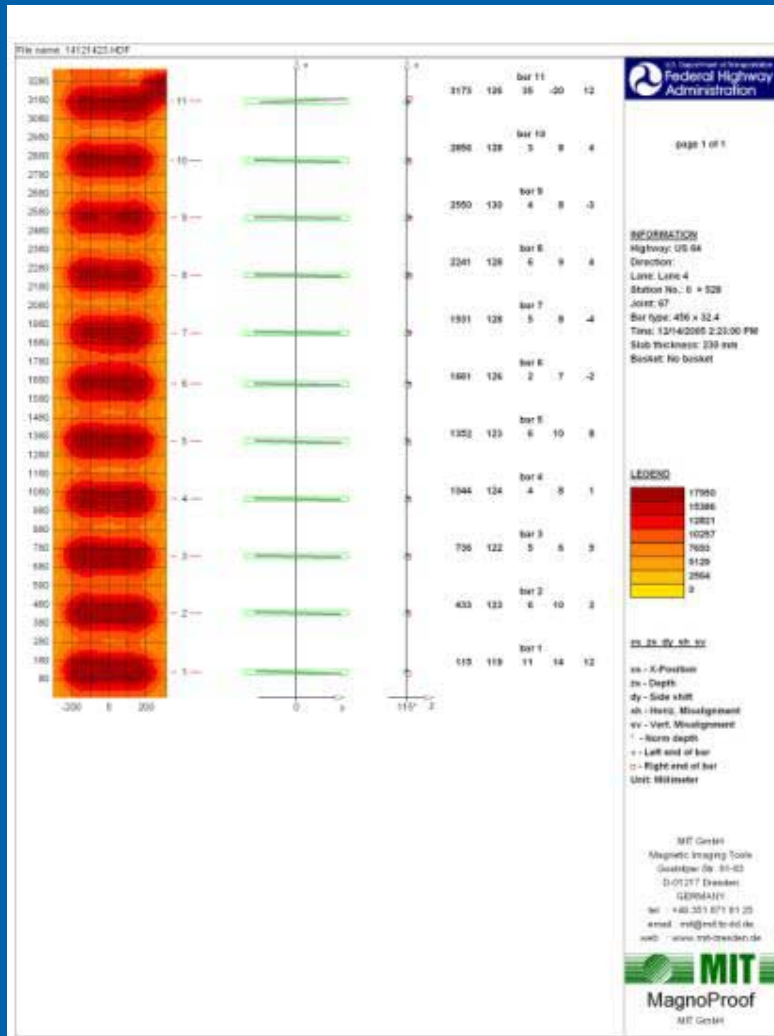
# Typical Results: I-64, Joint 67

Date + Time : 14/12/2005 14:23  
File g:\05\_12\_14\14121423.hdf

Highway : US 64  
Direction : E  
Station No. : 0 + 528  
Joint : 67  
Lane : Lane 4  
Bar type : 454 x 38mm  
Bar spacing : 300 mm  
Concrete thickness : 230 mm

Bar No.	x-Location	Depth	side shift	Misalignm. hor.	Misalignm. vert.	Bar space
	mm	mm	mm	mm	mm	mm
1	119	130	2	13	9	119
2	432	135	-0	9	-0	313
3	736	134	-1	6	6	304
4	1044	137	0	6	-1	308
5	1352	136	1	10	6	308
6	1658	139	-0	5	-4	306 D
7	1933	141	-1	6	-6	275 D
8	2241	141	-1	7	2	308 D
9	2550	143	-0	5	-4	309 D
10	2857	141	-1	6	2	307 D
11	3164	137	27	-2	9	307

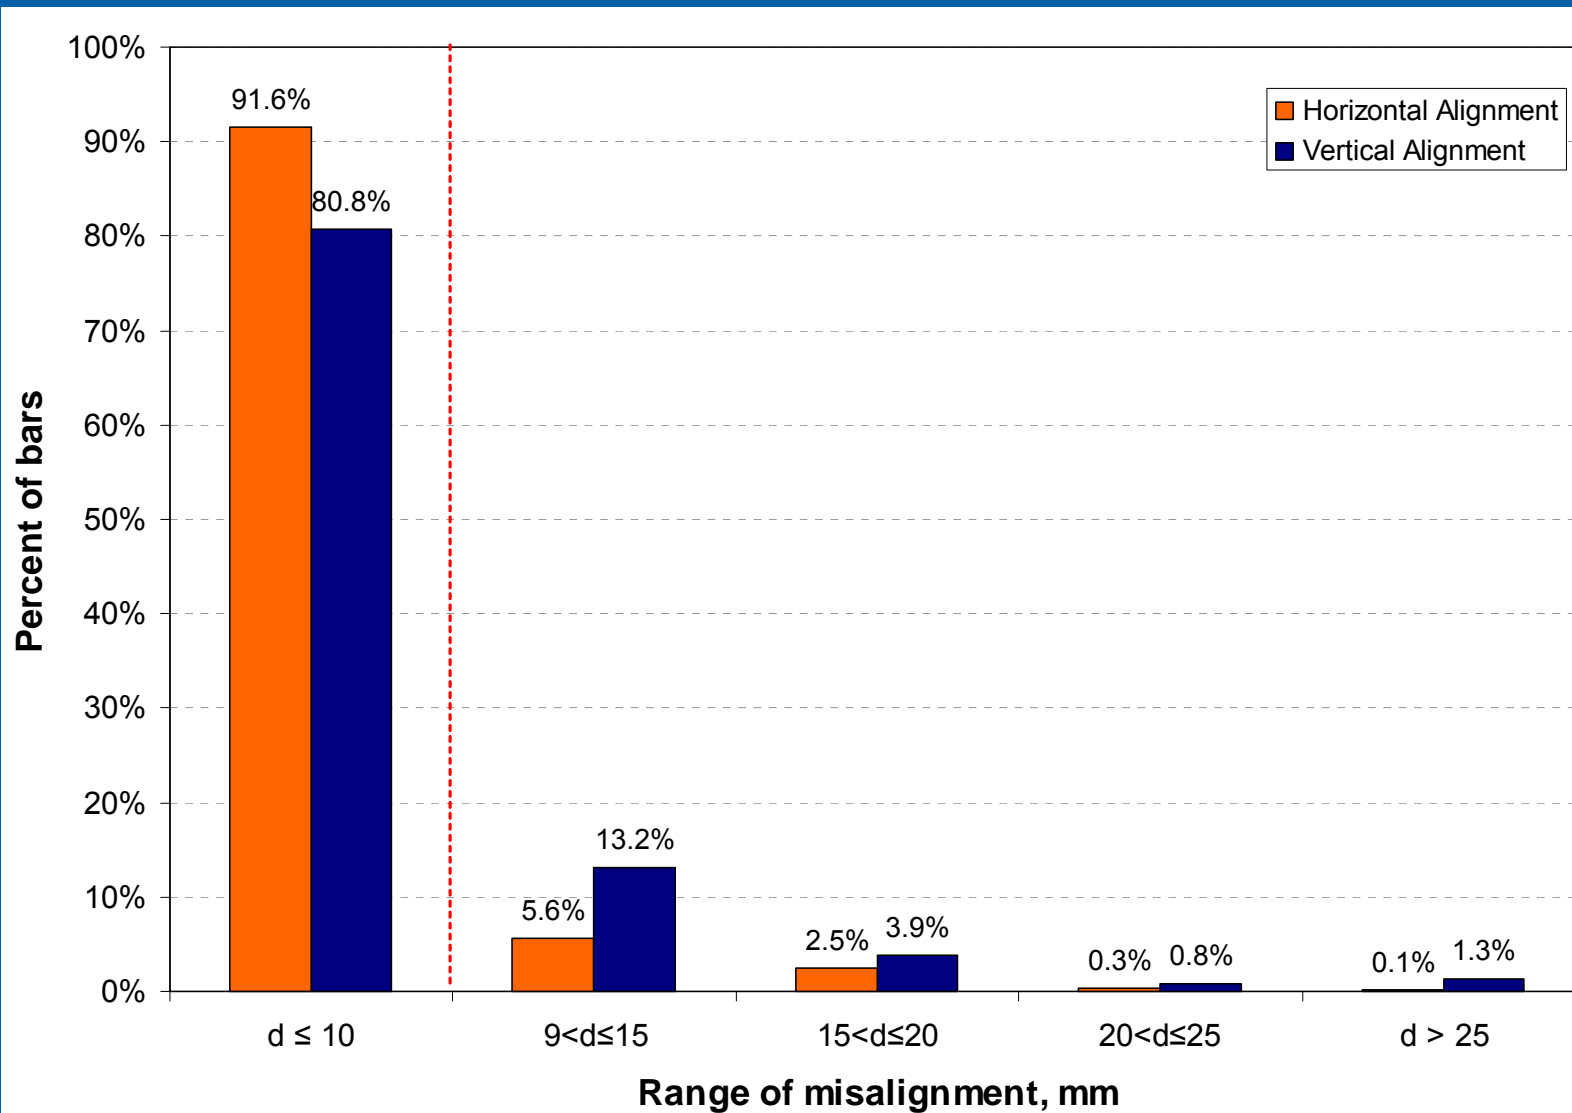
# Summary Result for I-64

- Reflects the risk of joint locking – the higher the Joint score, the higher the risk
- Determined as a sum of product of number of bars at each level of misalignment and weighting factors
- Further research is needed to refine Joint Score

Range of misalignment, mm	Weight
$10 < d \leq 15$	0
$15 < d \leq 20$	2
$20 < d \leq 25$	4
$25 < d \leq 38$	5
$38 < d$	10

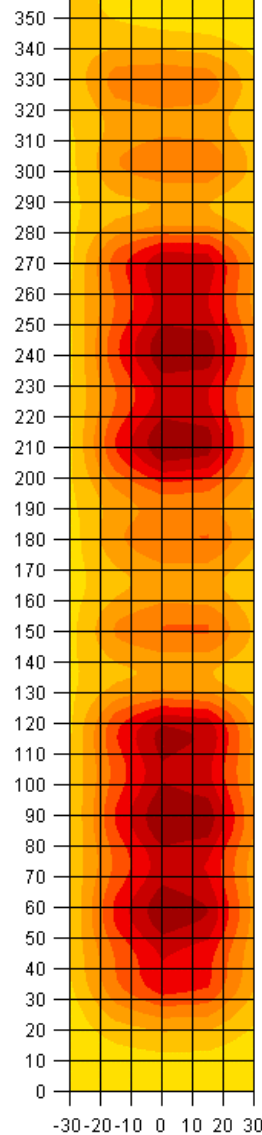
**Basket not cut**

Bars must be insulated (epoxy coated), and the basket shipping wire is cut.
